# Report Summary

The summary below consists of potentially significant findings. These findings can be a safety hazard, a deficiency requiring a major expense to correct or items I would like to draw extra attention to. The summary is not a complete listing of all the findings in the report, and reflects the opinion of the inspector. Please review all pages of the report as the summary alone does not explain all of the issues. All repairs should be done by a licensed & bonded tradesman or qualified professional. I recommend obtaining a copy of all receipts, warranties and permits for the work done.

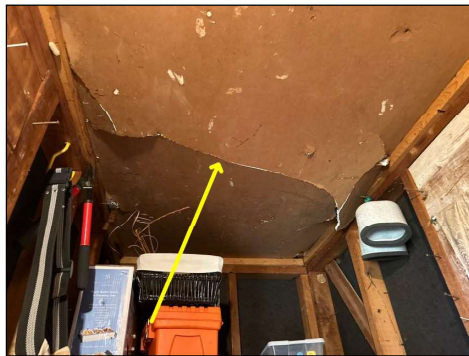
Page 16 Item: 6	Ceiling	Repair/replace damaged drywall in garage storage closet. Seal to promote gas/fire
-----------------	---------	---

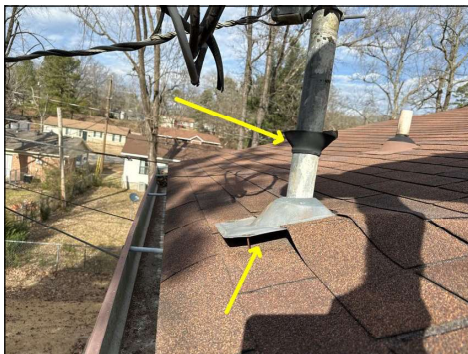
Raised flashing and rubber vent boot

Page 20 Item: 5	Accessories	<p>Consult a licensed roofing contractor to secure/seal flashing(s) and install proper vent boot on electrical mast to prevent possible moisture penetration and related damages.</p> <p>Consult a licensed roofing contractor to properly position exhaust collar(s) and caulk/seal to prevent possible moisture entry and subsequent damages.</p> <p>Consult a licensed roofing contractor to repair/replace damaged/cracked exhaust pipes to prevent moisture entry and related damages.</p> <p>Inverted vent boot. Vent boots should be coned shaped to allow water to drain off of the boot. Consult qualified contractor to repair or replace as needed to prevent moisture from pooling on top of vent boot.</p>
-----------------	-------------	---

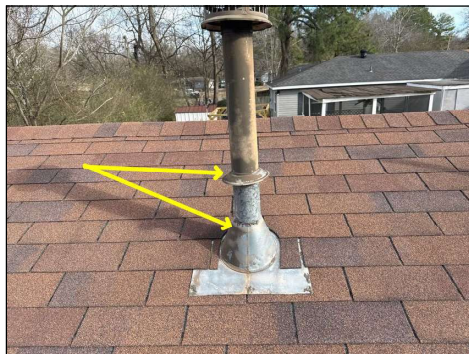
properly position exhaust collar(s)

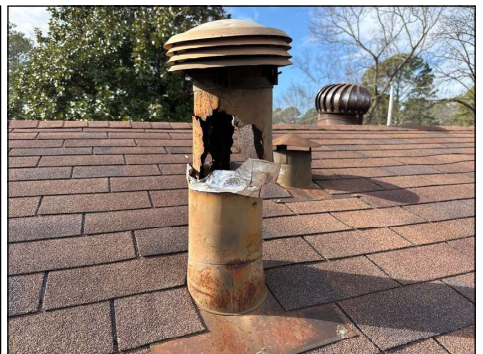
repair/replace damaged/cracked exhaust pipes

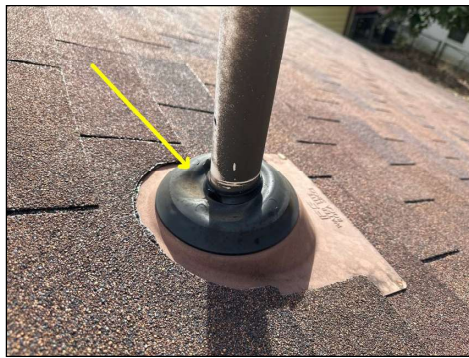
Inverted vent boot.

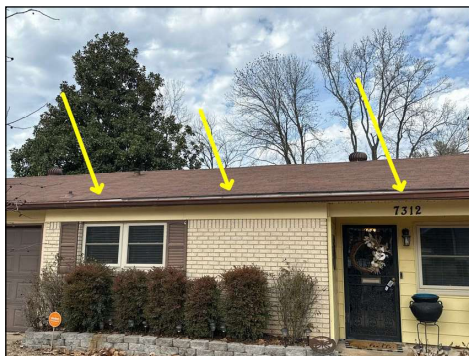
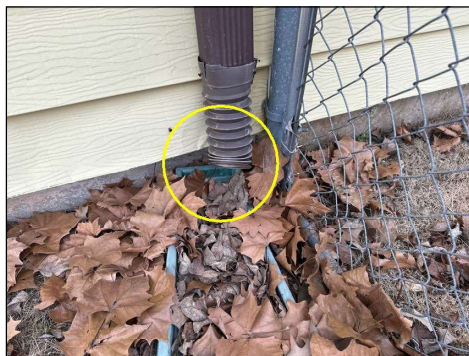
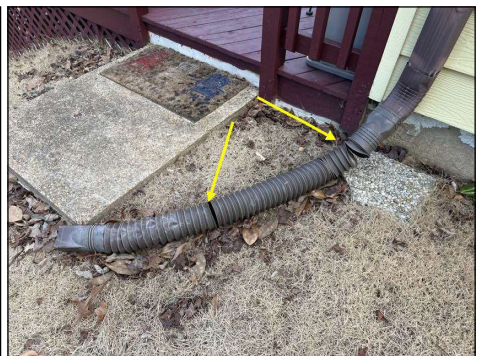
Page 21 Item: 7

**Gutters Sagging.** When there is a dip in the line of your gutters, it invites water to pool there or over flow in that area prevents proper drainage into the ground. Potential for fascia wood damage behind gutters. Loose hardware or damage to the gutter/fascia sections should be repaired by a qualified contractor to re-slope for proper drainage and to prevent damage to fascia boards and soffit. ( front of house, )

Replace damaged/missing elbows & leaders on downspouts and extend away from structure to prevent possible moisture related damages to structure and foundation.

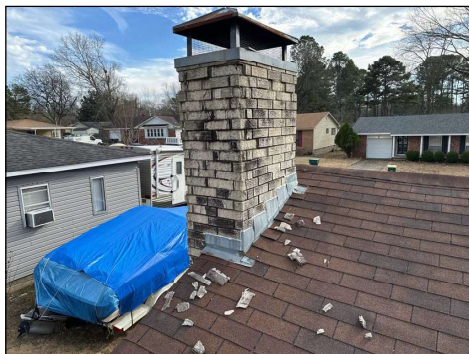
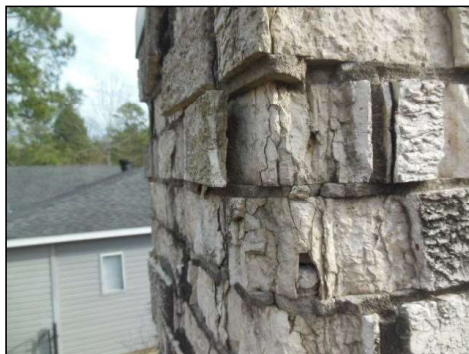
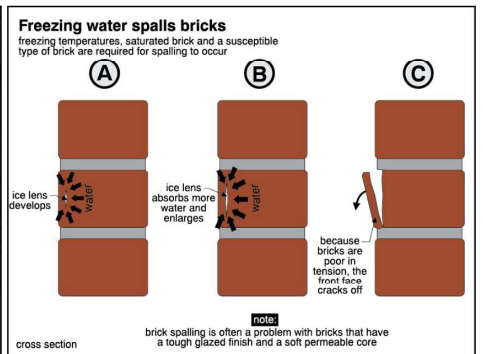
Page 22 Item: 9

**Spalling and/or damage of the masonry was present on the chimney.** This is indicative of moisture intrusion into the masonry, and as this moisture freezes and expands in winter months, damage to the brick occurs. Evaluation and repairs as needed are recommended to be conducted by a qualified chimney contractor or mason.

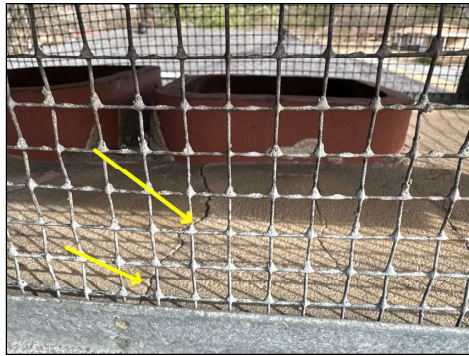
Page 23 Item: 11

Consult a qualified contractor to repair/seal gaps and cracks in crown to reduce potential moisture entry and related damages.

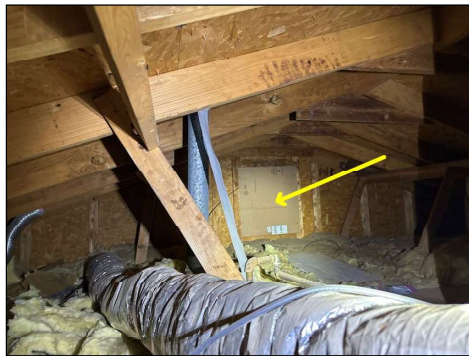
Gable vent on back of house was sealed with cardboard. Consult homeowner on reason it was sealed. ( My Thought it was sealed to prevent Water lines from freezing )

Sealed vent

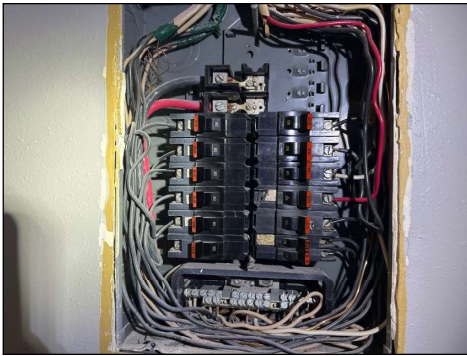
The electric panel is a Federal Pacific Stab-Lok system. Numerous problems are associated with this type of panel. The following is an excerpt from Inspectapedia, <http://www.inspectapedia.com/fpe/fpepanel.htm>: Federal Pacific Electric "Stab-Lok" service panels and breakers are a latent hazard and can fail to trip in response to over current, leading to electrical fires. The breakers may also fail to shut off internally even if the toggle is switched to "off." Some double-pole (240-Volt) FPE circuit breakers and single-pole FPE Stab-Lok circuit breakers simply do not work safely.

There are other FPE panel-defects independent of the breaker problems, panel and panel-bus fires and arcing failures in some equipment. The failure rates for these circuit breakers were and still are significant. In some cases failure to trip occurs 60% of the time - a serious fire and electrical shock hazard.

Failures are documented in the CPSC study and by independent research. Additional independent testing and research are on-going and are reported here. FPE Stab-Lok electrical panels should be replaced. Do not simply swap in some replacement breakers."

Breaker was damaged. Recommend electrician to replace damaged breaker for safety.

Consult a licensed electrician to evaluate and replace if needed.

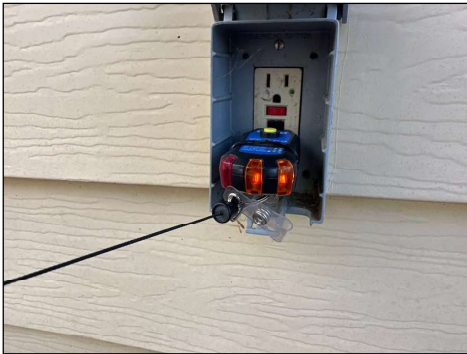
Both exterior back deck receptacles

Both **GFCI** unit(s) on exterior back deck did not trip when tested. Unit(s) did have power. Consult a licensed electrician to replace to provide intended shock protection.

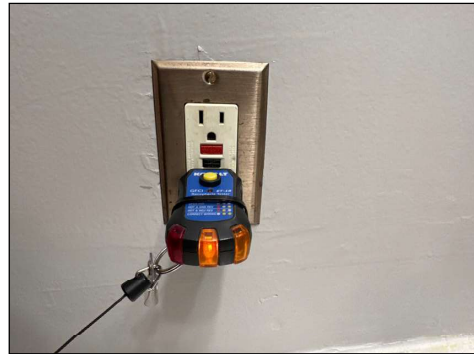
hall bathroom

Receptacle read open ground when tested. Consult a licensed electrician to repair to regain intended grounding protection. ( hall bathroom, )

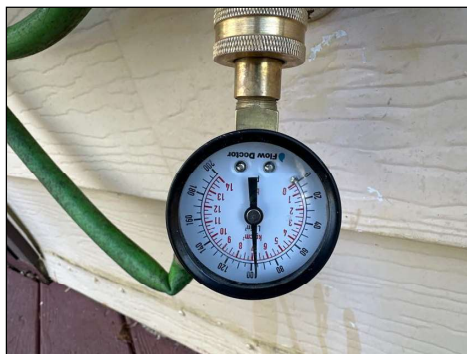
Water pressure at exterior hose faucet was high. Normal water pressure is 50psi - 80psi. The reading at this faucet was approximately 95 psi. Any readings over 75 psi indicate a missing or defective pressure regulator. High water pressure can create additional wear and tear on the plumbing fittings and household appliances. Consult licensed plumber to locate pressure regulator and repair/adjust/replace as needed to regulate pressure.

Approximately 95 psi

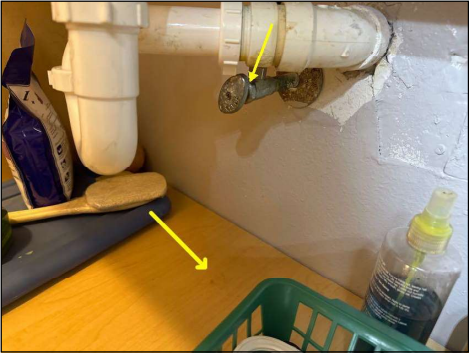
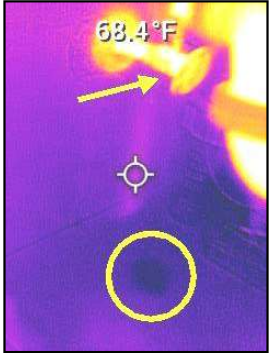
Right bedroom bathroom

Page 35 Item: 6	Sink Observations	Leak on shutoff of right side bedroom bathroom sink(s). Consult a licensed plumber to repair.
-----------------	-------------------	---

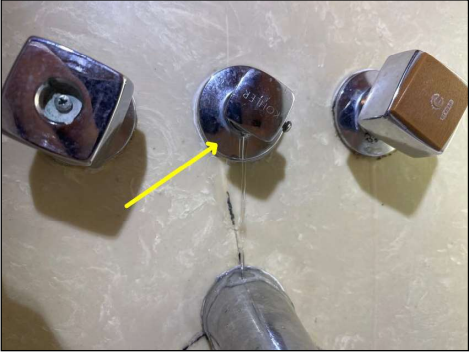
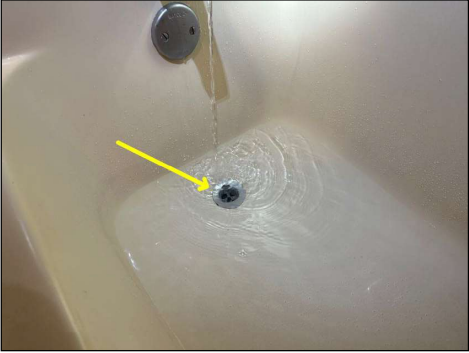
Page 36 Item: 8	Bathtubs/showers Observations	<p>Handle on hall bathroom tub faucet leaked when tested. Water ran into tub. Repair to conserve water and prevent possible moisture related damages.</p> <p>Consult a licensed plumber to determine cause of slow drain in back hall bathroom bathtub(s). Repair as needed.</p>
-----------------	-------------------------------	--

Back hall, bathroom slow drain

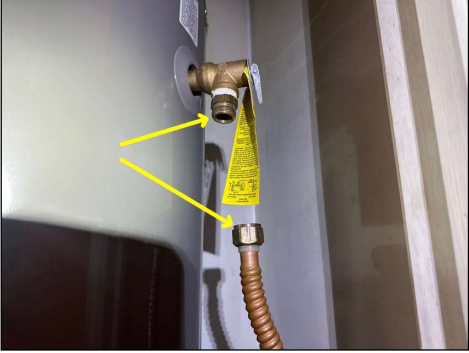
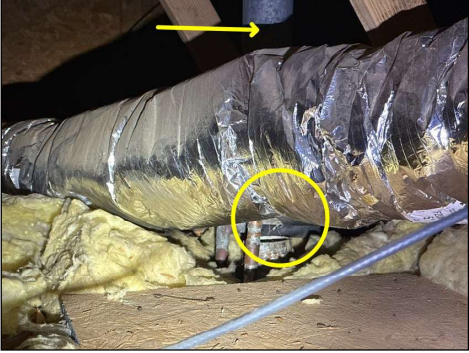
Page 38 Item: 12	Water Heater	<p>Pressure relief valve discharge line was not installed. Consult a licensed plumber to install line to the exterior to prevent possible moisture related damages.</p> <p>Safety Concern: The exhaust pipe was disconnected in the attic allowing carbon monoxide to escape into attic/home. Consult a licensed plumber to repair/connect to ensure safe exhaust. (Note: Recommend repair prior to ceiling repair in bedroom, easy to get to from there, difficult to access from scuttle hole access in front bedroom. Take picture to prove it was done.)</p>
------------------	--------------	--

The exhaust pipe was disconnected in attic

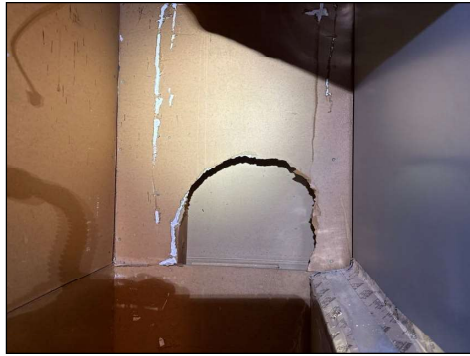
Page 41 Item: 3	Walls	Damaged drywall in referenced areas. Recommend qualified contractor to make repairs as needed. (Furnace closets, )
-----------------	-------	--

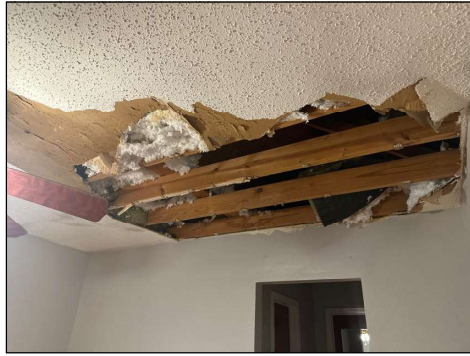
Page 42 Item: 4	Ceiling	Damaged area(s) present. Consult a licensed contractor to repair/replace as needed. ( Right side bedroom, )
-----------------	---------	---
