OVER & UNDER
PROPERTY INSPECTION

Visual Property Inspection

1111 Sample Dr, Little Rock, AR 72209
Inspection prepared for: John Q Public
Date of Inspection: 1/6/2023 Time: 2:00 PM
Age of Home: 1966 Size: 1842

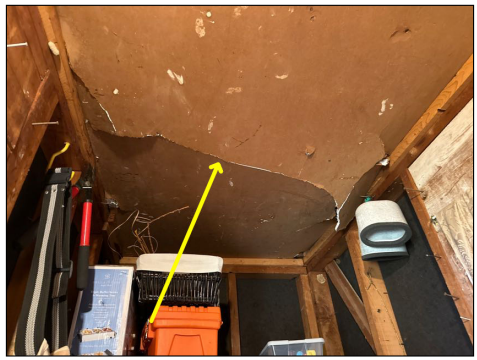
Page 16 Item: 6	Ceiling	Repair/replace damaged drywall in garage storage closet. Seal to promote gas/fire
-----------------	---------	---

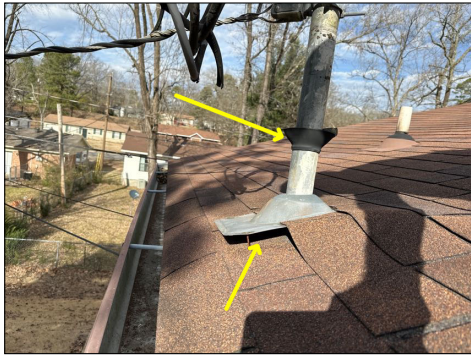
Raised flashing and rubber vent boot

Page 20 Item: 5	Accessories	<p>Consult a licensed roofing contractor to secure/seal flashing(s) and install proper vent boot on electrical mast to prevent possible moisture penetration and related damages.</p> <p>Consult a licensed roofing contractor to properly position exhaust collar(s) and caulk/seal to prevent possible moisture entry and subsequent damages.</p> <p>Consult a licensed roofing contractor to repair/replace damaged/cracked exhaust pipes to prevent moisture entry and related damages.</p> <p>Inverted vent boot. Vent boots should be coned shaped to allow water to drain off of the boot. Consult qualified contractor to repair or replace as needed to prevent moisture from pooling on top of vent boot.</p>
-----------------	-------------	---

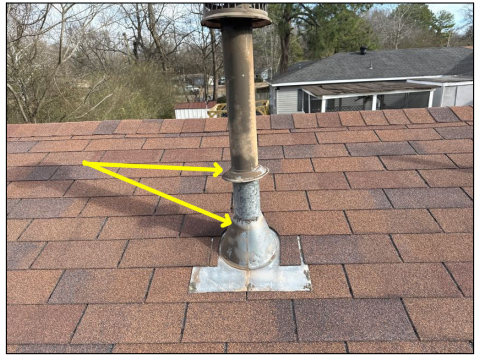
properly position exhaust collar(s)

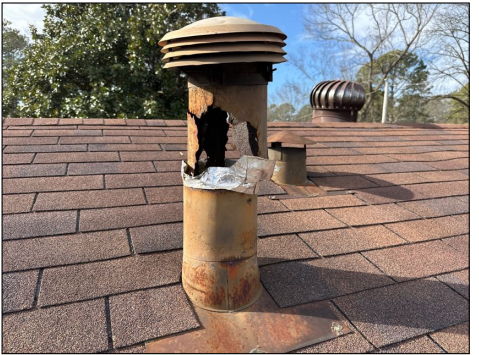
repair/replace damaged/cracked exhaust pipes

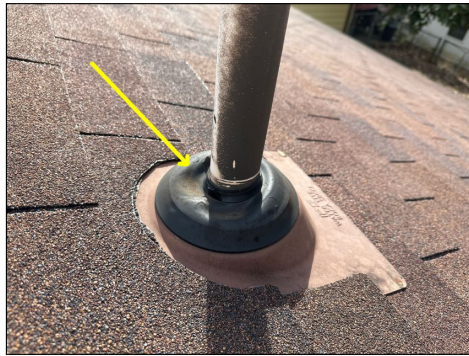
Inverted vent boot.

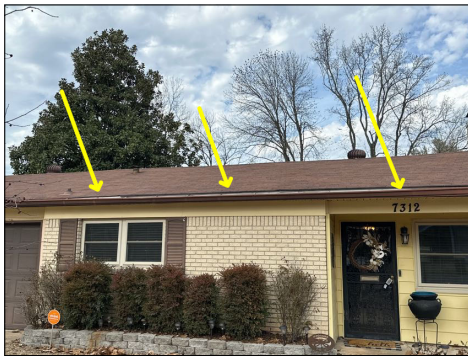
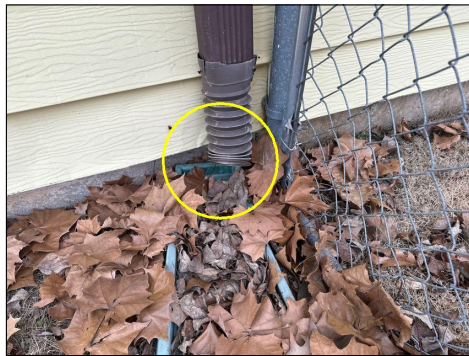
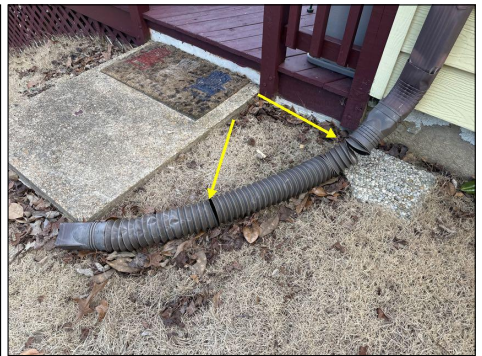
Page 21 Item: 7

Gutters Sagging. When there is a dip in the line of your gutters, it invites water to pool there or over flow in that area prevents proper drainage into the ground. Potential for fascia wood damage behind gutters. Loose hardware or damage to the gutter/fascia sections should be repaired by a qualified contractor to re-slope for proper drainage and to prevent damage to fascia boards and soffit. (front of house,)

Replace damaged/missing elbows & leaders on downspouts and extend away from structure to prevent possible moisture related damages to structure and foundation.

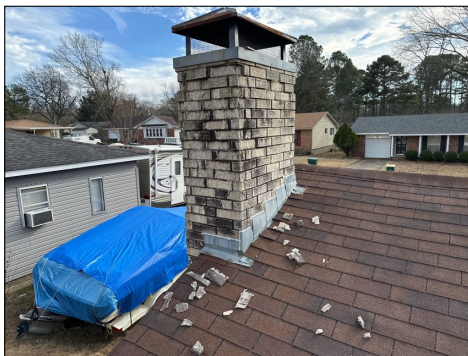
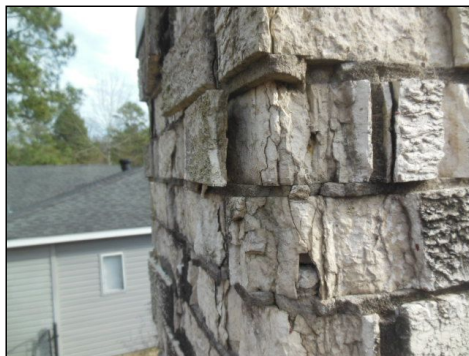
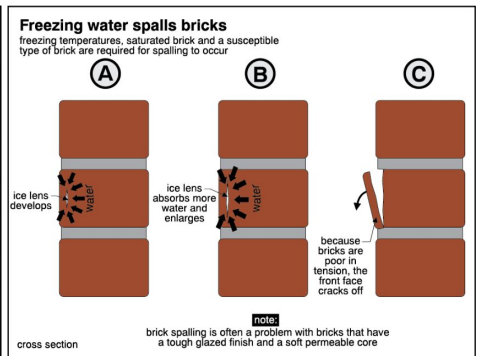
Page 22 Item: 9

Spalling and/or damage of the masonry was present on the chimney. This is indicative of moisture intrusion into the masonry, and as this moisture freezes and expands in winter months, damage to the brick occurs. Evaluation and repairs as needed are recommended to be conducted by a qualified chimney contractor or mason.

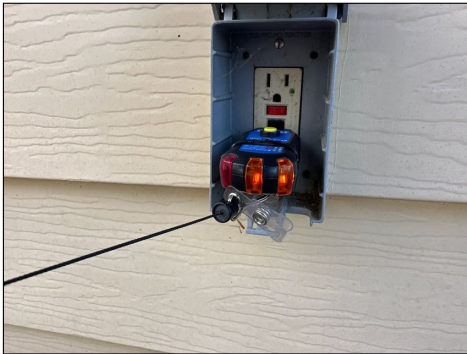
Both **GFC** unit(s) on exterior back deck did not trip when tested. Unit(s) did have power. Consult a licensed electrician to replace to provide intended shock protection.

Both exterior back deck receptacles

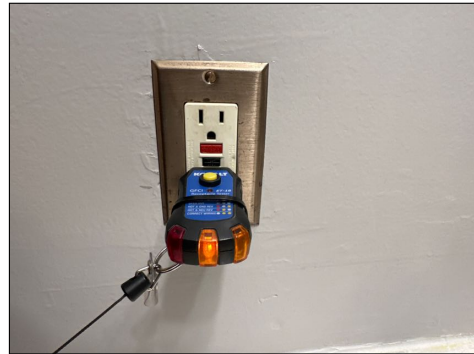
Receptacle read open ground when tested. Consult a licensed electrician to repair to regain intended grounding protection. (hall bathroom,)

hall bathroom

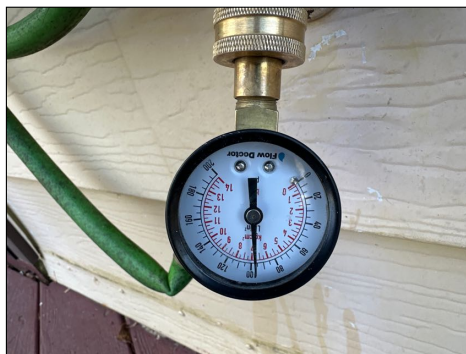
Water pressure at exterior hose faucet was high. Normal water pressure is 50psi - 80psi. The reading at this faucet was approximately 95 psi. Any readings over 75 psi indicate a missing or defective pressure regulator. High water pressure can create additional wear and tear on the plumbing fittings and household appliances. Consult licensed plumber to locate pressure regulator and repair/adjust/replace as needed to regulate pressure.

Approximately 95 psi

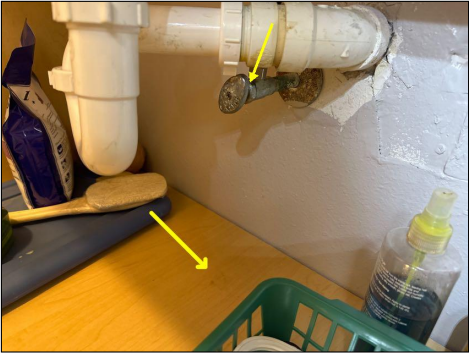
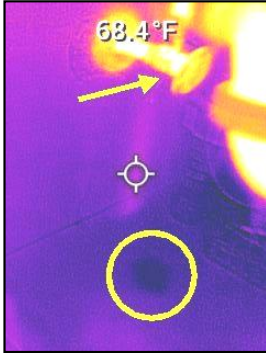
Right bedroom bathroom

Page 35 Item: 6 Sink Observations Leak on shutoff of right side bedroom bathroom sink(s). Consult a licensed plumber to repair.

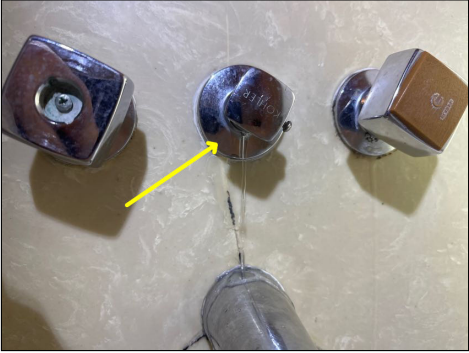
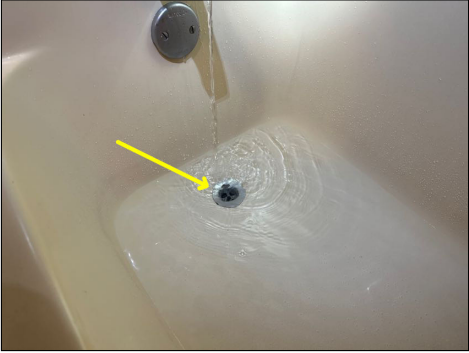
Page 36 Item: 8 Bathtubs/showers Observations Handle on hall bathroom tub faucet leaked when tested. Water ran into tub. Repair to conserve water and prevent possible moisture related damages. Consult a licensed plumber to determine cause of slow drain in back hall bathroom bathtub(s). Repair as needed.

Back hall, bathroom slow drain

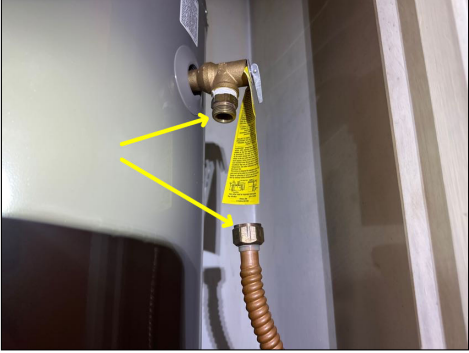
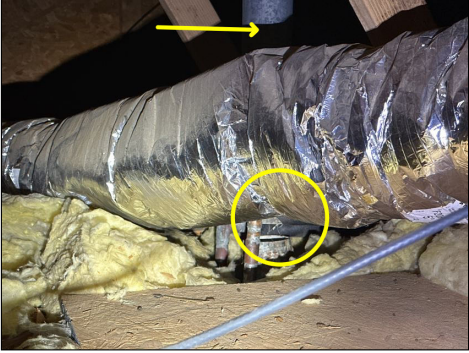
Page 38 Item: 12 Water Heater Pressure relief valve discharge line was not installed. Consult a licensed plumber to install line to the exterior to prevent possible moisture related damages. Safety Concern: The exhaust pipe was disconnected in the attic allowing carbon monoxide to escape into attic/home. Consult a licensed plumber to repair/connect to ensure safe exhaust. (Note: Recommend repair prior to ceiling repair in bedroom, easy to get to from there, difficult to access from scuttle hole access in front bedroom. Take picture to prove it was done.)

The exhaust pipe was disconnected in attic

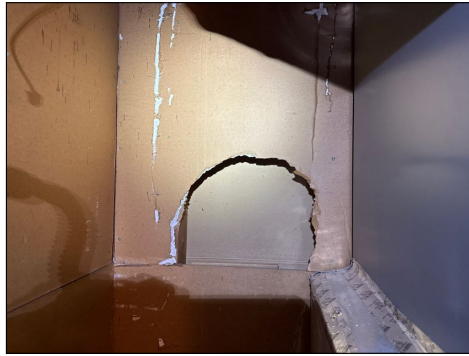
Page 41 Item: 3 Walls Damaged drywall in referenced areas. Recommend qualified contractor to make repairs as needed. (Furnace closets,)

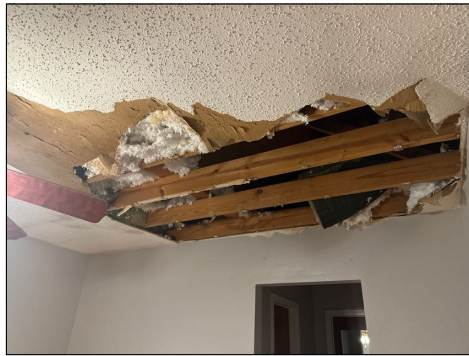
Page 42 Item: 4 Ceiling Damaged area(s) present. Consult a licensed contractor to repair/replace as needed. (Right side bedroom,)

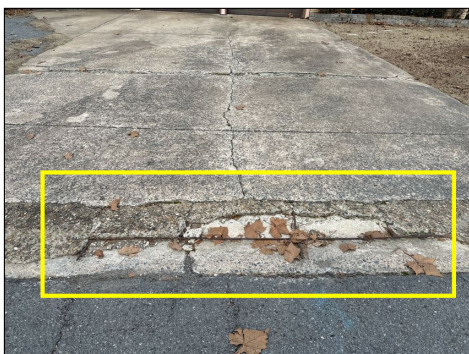
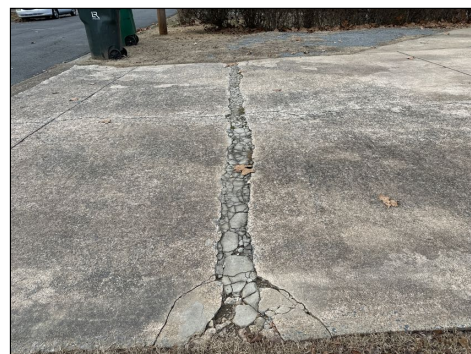
There were moderate to heavy cracks present on areas of the concrete slab. Also previous repairs across driveway that was filled in with gravel and not fully re-sealed. An evaluation of the cracks is recommended to be performed by a foundation or concrete contractor with repairs made as needed.

Previous repairs

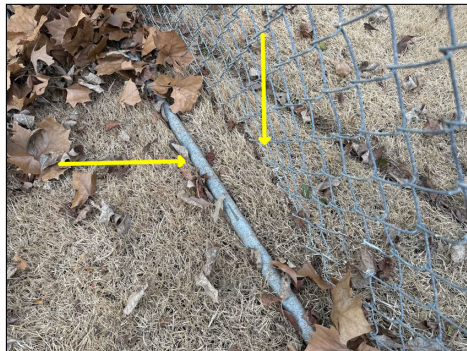
Chain-link gate on right side fencing is not connected to bottom rail recommend repairs to prevent pets from getting out of the yard

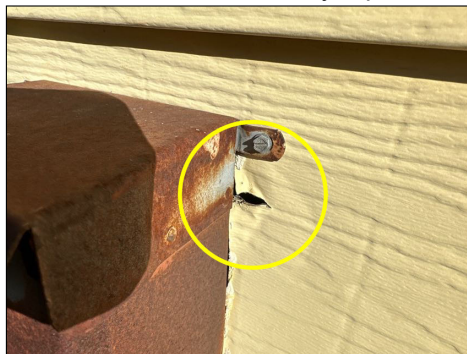
Fill/seal any unsealed gaps/penetrations in exterior wall surface to prevent possible moisture/pest/vermin entry and subsequent damages. Monitor to ensure repairs remain active. Make additional repairs if needed. This inexpensive task aids in the prevention of moisture intrusion and saves on costly repairs.

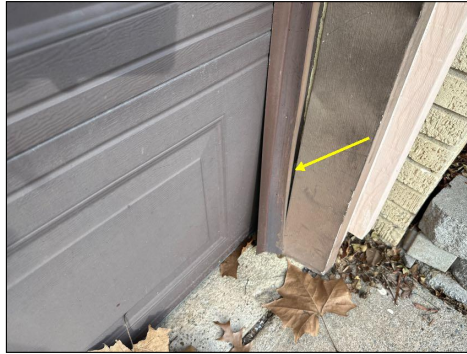
Note: Both Door(s) we're dented, but appeared functional. Repair/replace as needed.

Slight damage to left garage door, interior insulation. Repair desired.

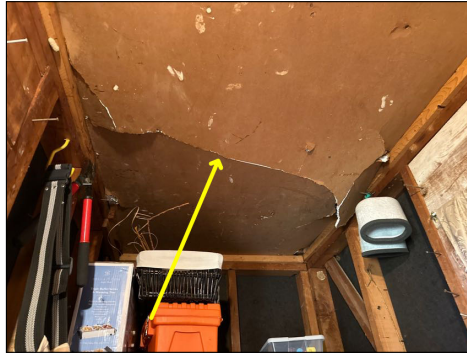
Repair/replace damaged drywall in garage storage closet. Seal to promote gas/fire

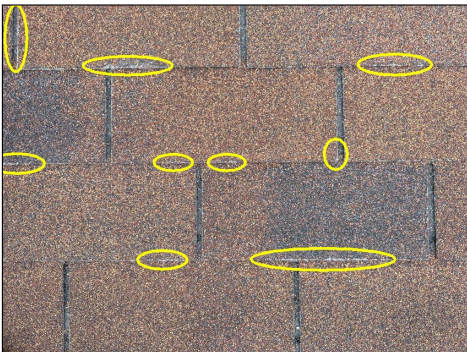
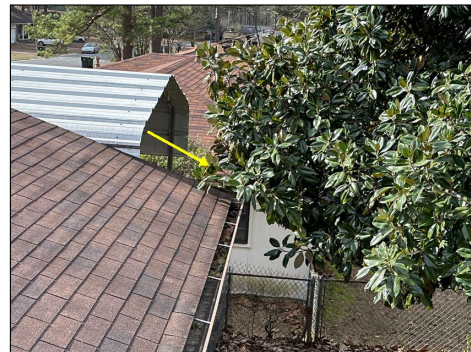
Possible slight hail damage on roof. Shingles showing some areas of granules loss, condition is relative to age. To determine whether the level of granule loss is acceptable or is a cause for alarm, it is best to ask your roofer to evaluate. If you have any concerns, and make repairs as directed.

Trim vegetation to prevent premature wear of finish materials.

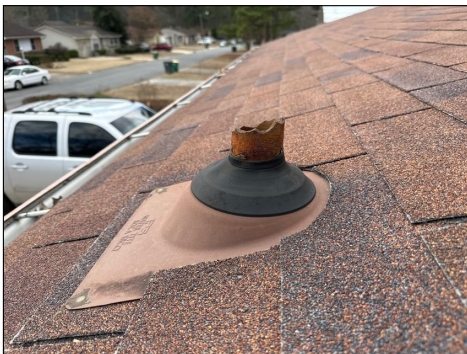
Pipe short

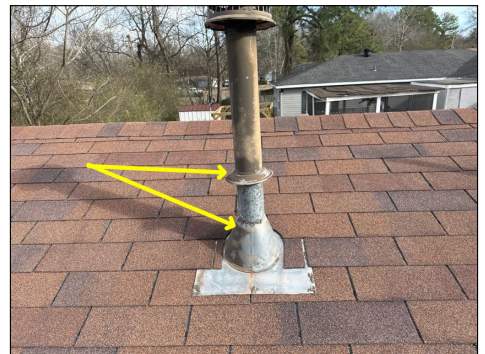
properly position exhaust collar(s)

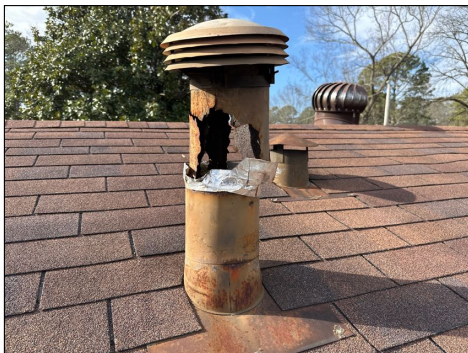
repair/replace damaged/cracked exhaust pipes

Consult a licensed roofing contractor to repair/replace damaged/cracked exhaust pipes to prevent moisture entry and related damages.

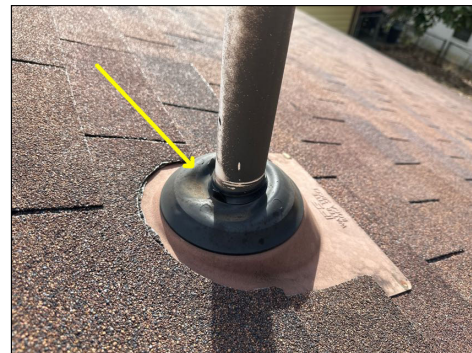
Inverted vent boot. Vent boots should be coned shaped to allow water to drain off of the boot. Consult qualified contractor to repair or replace as needed to prevent moisture from pooling on top of vent boot.

Inverted vent boot.

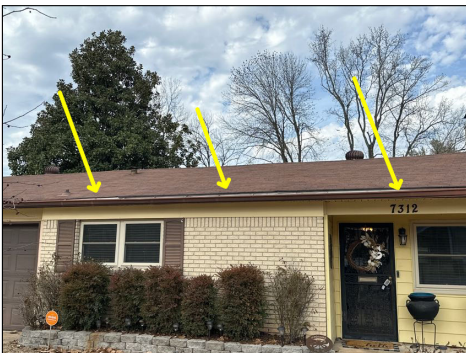
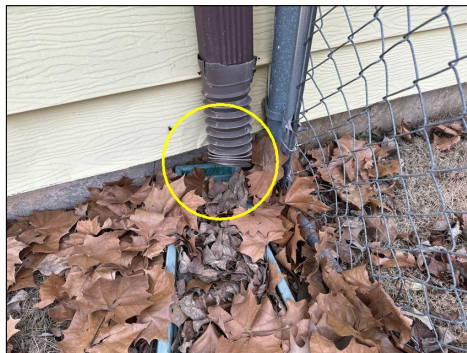
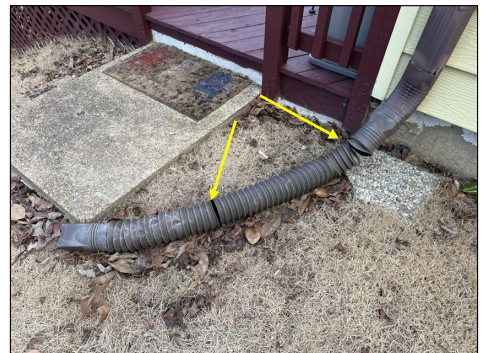
Gutters Sagging. When there is a dip in the line of your gutters, it invites water to pool there or over flow in that area prevents proper drainage into the ground. Potential for fascia wood damage behind gutters. Loose hardware or damage to the gutter/fascia sections should be repaired by a qualified contractor to re-slope for proper drainage and to prevent damage to fascia boards and soffit. (front of house,)

Replace damaged/missing elbows & leaders on downspouts and extend away from structure to prevent possible moisture related damages to structure and foundation.

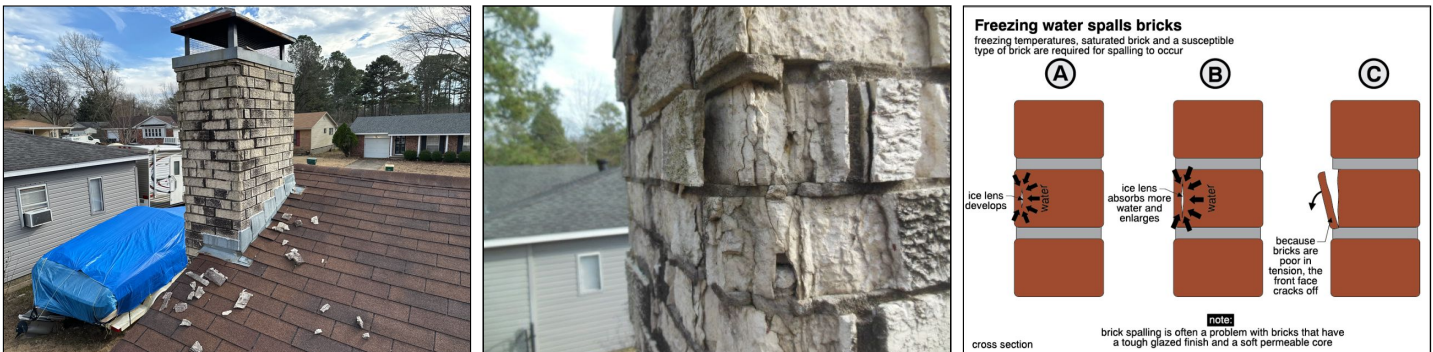
Spalling and/or damage of the masonry was present on the chimney. This is indicative of moisture intrusion into the masonry, and as this moisture freezes and expands in winter months, damage to the brick occurs. Evaluation and repairs as needed are recommended to be conducted by a qualified chimney contractor or mason.

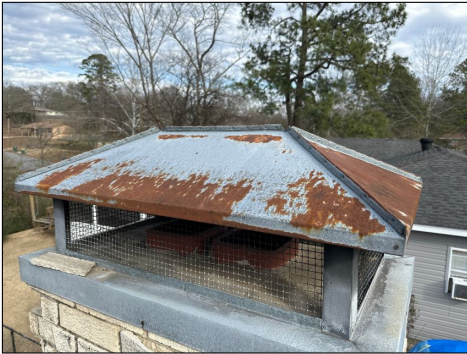
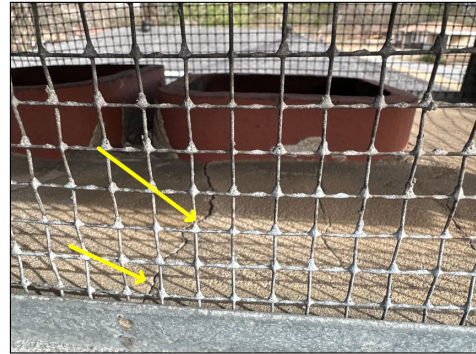
Consult a qualified contractor to repair/seal gaps and cracks in crown to reduce potential moisture entry and related damages.

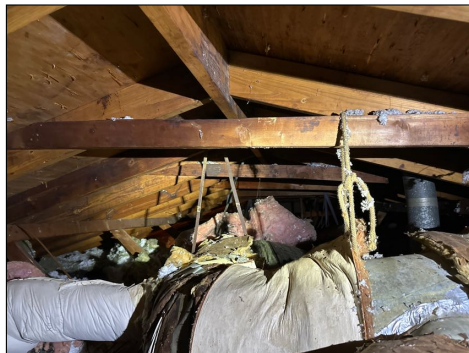
Limited access. Ductwork in addition blocking full access. Unable to access full attic.

Addition access limited.

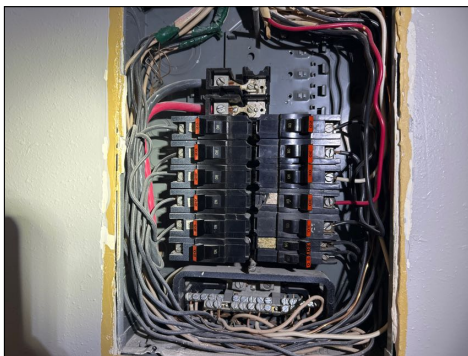
Hallway Panel

Breaker was damaged. Recommend electrician to replace damaged breaker for safety.

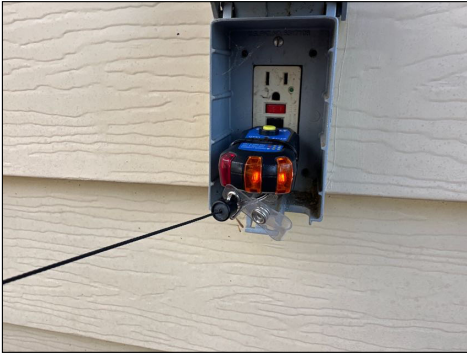
Both exterior back deck receptacles

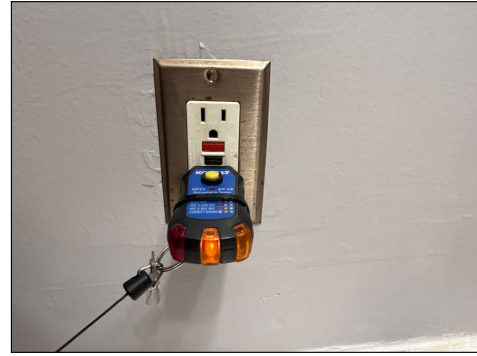
Receptacle read open ground when tested. Consult a licensed electrician to repair to regain intended grounding protection. (hall bathroom,)

hall bathroom

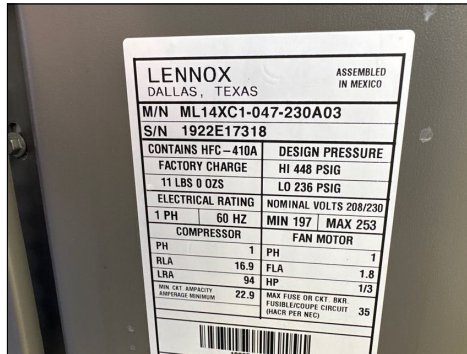
Unable to test **A/C** unit due to low outdoor temperature. Testing A/C unit during low outdoor temperatures can cause system failure. Recommend having unit serviced/evaluated by a licensed heating and air conditioning technician to ensure proper operation. A/C Unit is excluded from this inspection.

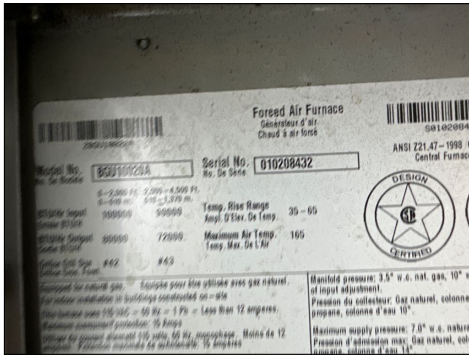
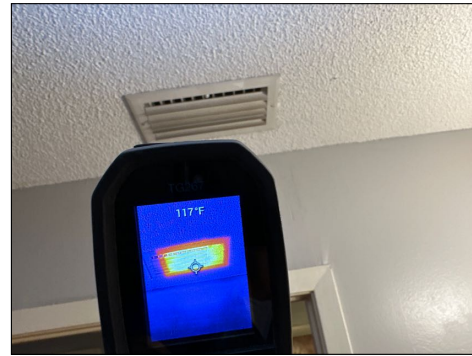
Budget to replace. Unit has exceeded typical life expectancy.

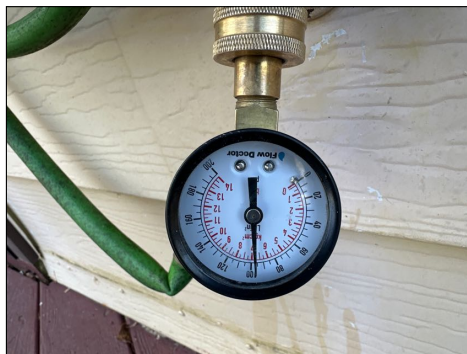
Water pressure at exterior hose faucet was high. Normal water pressure is 50psi - 80psi. The reading at this faucet was approximately 95 psi. Any readings over 75 psi indicate a missing or defective pressure regulator. High water pressure can create additional wear and tear on the plumbing fittings and household appliances. Consult licensed plumber to locate pressure regulator and repair/adjust/replace as needed to regulate pressure.

Approximately 95 psi

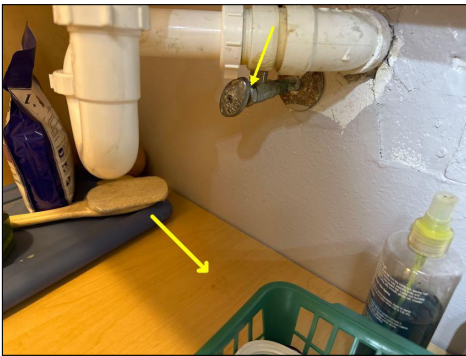
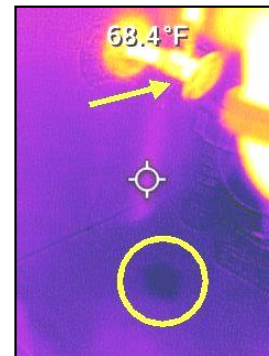
Right bedroom bathroom

Leak on shutoff of right side bedroom bathroom sink(s). Consult a licensed plumber to repair.

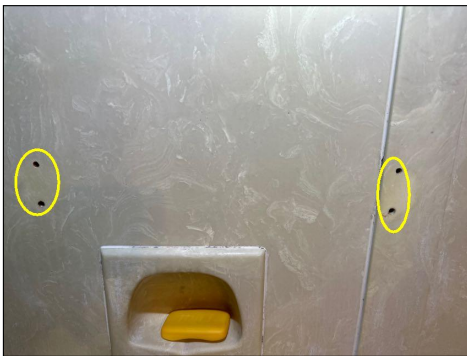
Fill open holes

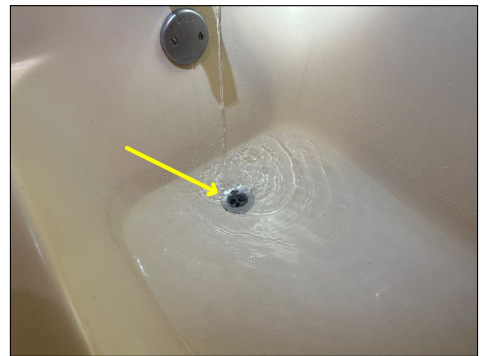
Consult a licensed plumber to determine cause of slow drain in back hall bathroom bathtub(s). Repair as needed.

Back hall, bathroom slow drain

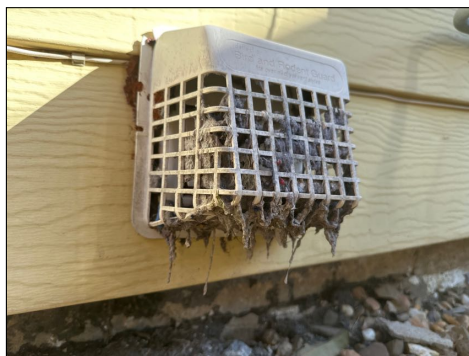
Recommended Maintenance: Clean dryer exhaust line to promote safe operation.

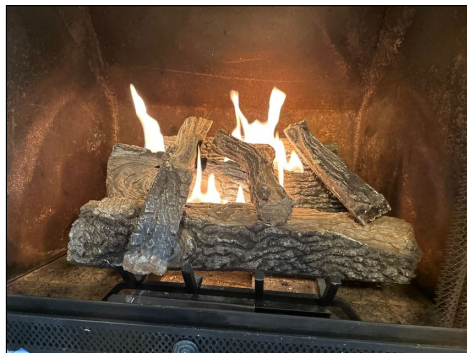
Logs appear to be for a vented system. If vented, open damper when in use, to promote safe operation. Current safety guidelines recommend that "damper stop clamps" be installed to lock the damper in the open position, as carbon monoxide is odorless and a significant health hazard.

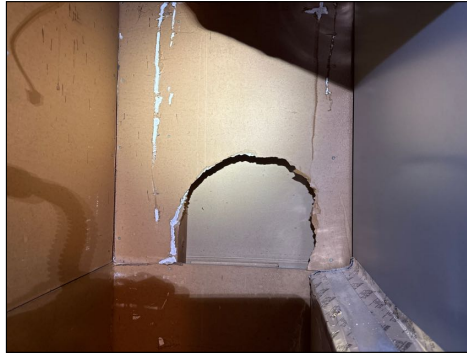
Damaged drywall in referenced areas. Recommend qualified contractor to make repairs as needed. (Furnace closets,)

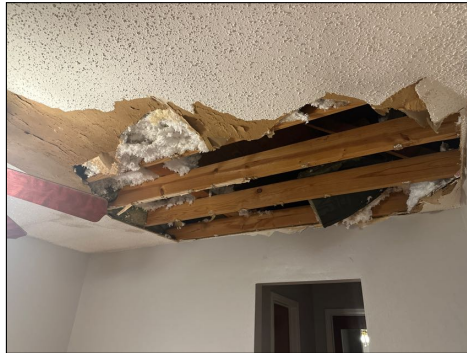
Damaged area(s) present. Consult a licensed contractor to repair/replace as needed. (Right side bedroom,)
