OVER & UNDER
PROPERTY INSPECTION

Visual Property Inspection

1111 Sample Dr, Little Rock, AR 72209
Inspection prepared for: John Q Public
Date of Inspection: 1/6/2023 Time: 2:00 PM
Age of Home: 1966 Size: 1842

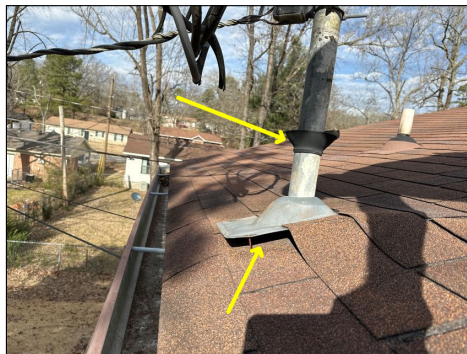
Raised flashing and rubber vent boot

Page 20 Item: 5	Accessories	<p>Consult a licensed roofing contractor to secure/seal flashing(s) and install proper vent boot on electrical mast to prevent possible moisture penetration and related damages.</p> <p>Consult a licensed roofing contractor to properly position exhaust collar(s) and caulk/seal to prevent possible moisture entry and subsequent damages.</p> <p>Consult a licensed roofing contractor to repair/replace damaged/cracked exhaust pipes to prevent moisture entry and related damages.</p> <p>Inverted vent boot. Vent boots should be coned shaped to allow water to drain off of the boot. Consult qualified contractor to repair or replace as needed to prevent moisture from pooling on top of vent boot.</p>
-----------------	-------------	---

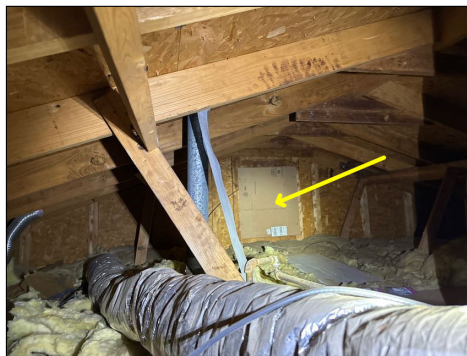
Sealed vent

Gable vent on back of house was sealed with cardboard. Consult homeowner on reason it was sealed. (My Thought it was sealed to prevent Water lines from freezing)

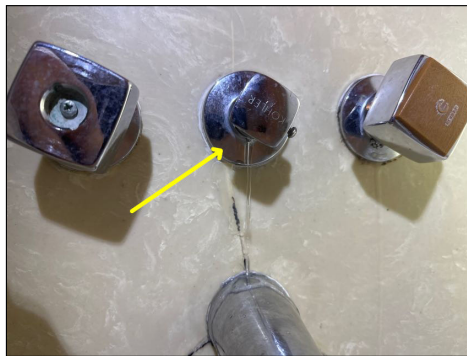
Back hall, bathroom slow drain

Page 36 Item: 8 Bathtubs/showers Observations Handle on hall bathroom tub faucet leaked when tested. Water ran into tub. Repair to conserve water and prevent possible moisture related damages. Consult a licensed plumber to determine cause of slow drain in back hall bathroom bathtub(s). Repair as needed.

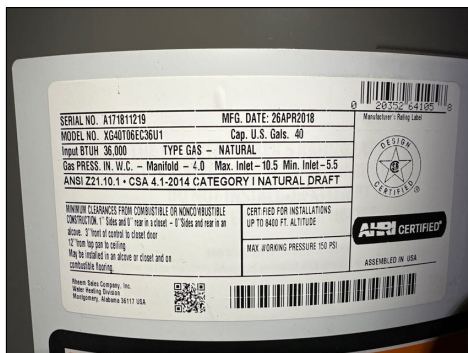
The exhaust pipe was disconnected in attic

Page 38 Item: 12 Water Heater Pressure relief valve discharge line was not installed. Consult a licensed plumber to install line to the exterior to prevent possible moisture related damages. Safety Concern: The exhaust pipe was disconnected in the attic allowing carbon monoxide to escape into attic/home. Consult a licensed plumber to repair/connect to ensure safe exhaust. (Note: Recommend repair prior to ceiling repair in bedroom, easy to get to from there, difficult to access from scuttle hole access in front bedroom. Take picture to prove it was done.)
